**26th March 2025**

Continuous Learning & Improvement Cascade Eastern Region Capital Programmes

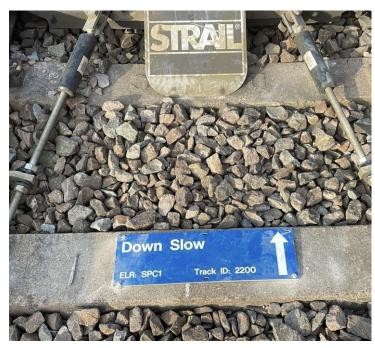
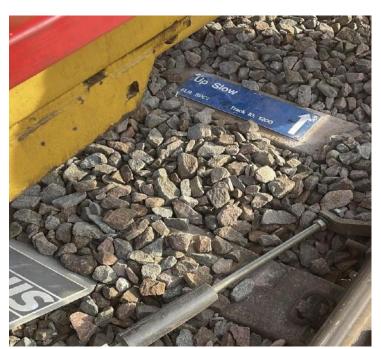
**Installed Track Markers**

The SRSA Enhancements team is now underway with the construction of the Wixams Station, South of Bedford. The team has now installed track ID markers at its various rail access points. The scheme located on the Midland Mainline between Flitwick and Bedford Stations contains both Fast and Slow lines.

The markers are now plated on the Up and Down Slow lines. Further markers will be installed on the Fast lines and at four other access points the project will be using throughout the works.

The aim is to mitigate any confusion for staff in determining which lines are under possession. It will also help to familiarise staff when accessing different rail access points. This will enhance the Safe System of Work measures with the use of the markers providing an added layer of protection for staff working on or near the line of route.
