CLIC

Safety Events Digest

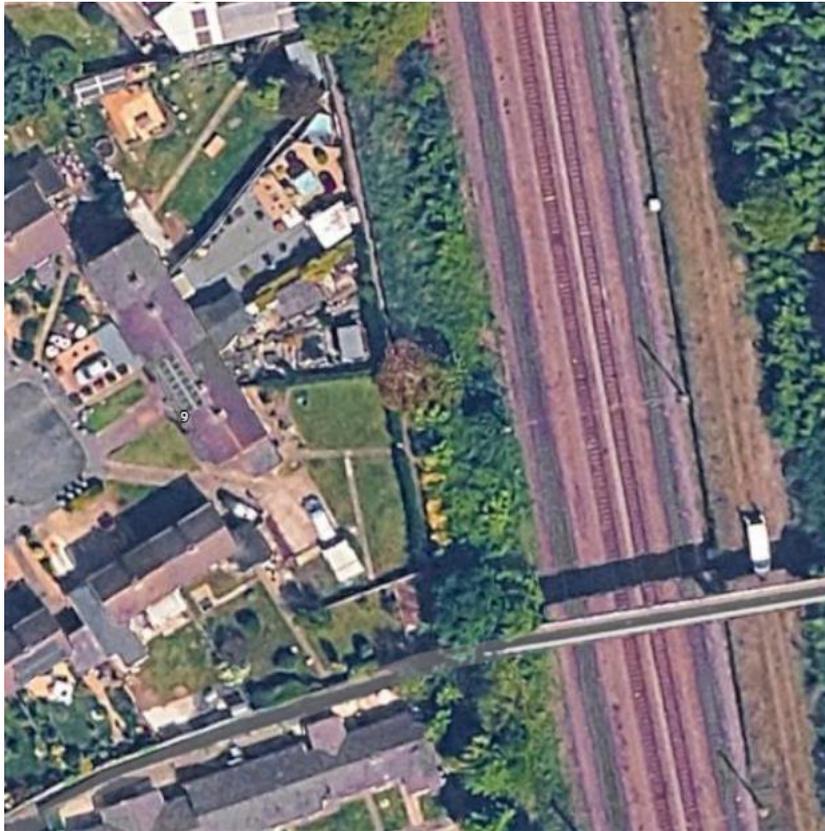
- Staff working near bridge 119 were shot at with air rifle from the lineside bushes.
- No-one has been injured.

- Members of public were firing shots at staff while on site.

- reported to on call.
- Police were called.
- Armed police have attended to secure the area.

- Complete welfare checks on the staff involved.

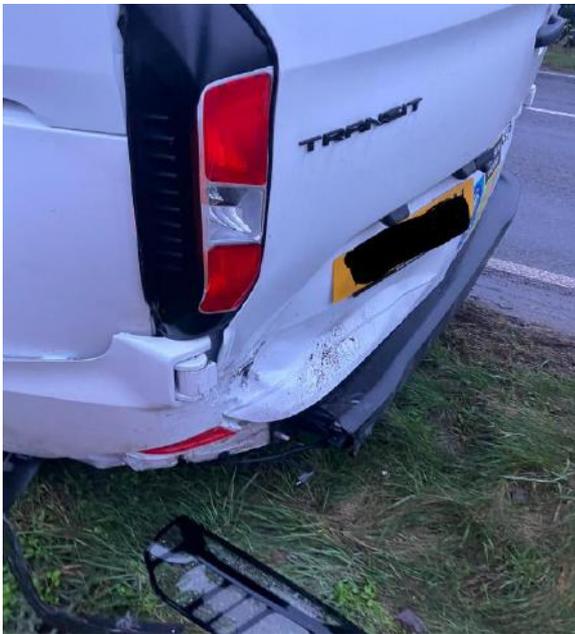
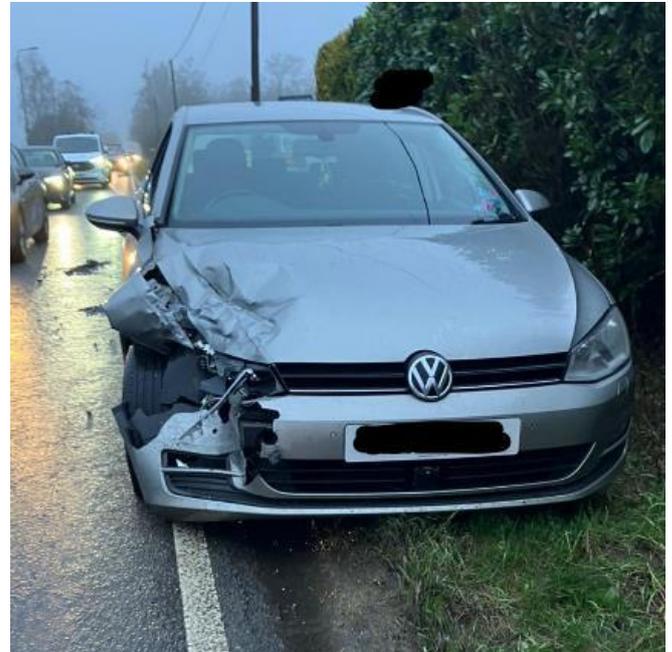
MOS was decelerating steadily as they approached traffic, when they had almost come to a stop. Vehicle behind them failed to slow down and collided with the back of MOS' vehicle. Moderate damage to MOS van and major damage to 3rd party vehicle.

- 3rd party driver was arrested for being under the influence.
- No injuries sustained.

- Emergency services were called, both ambulance and police arrived at the scene.

- Investigation is on-going, a full investigation report will be provided.
- Shared learning will be distributed once the investigation is complete.

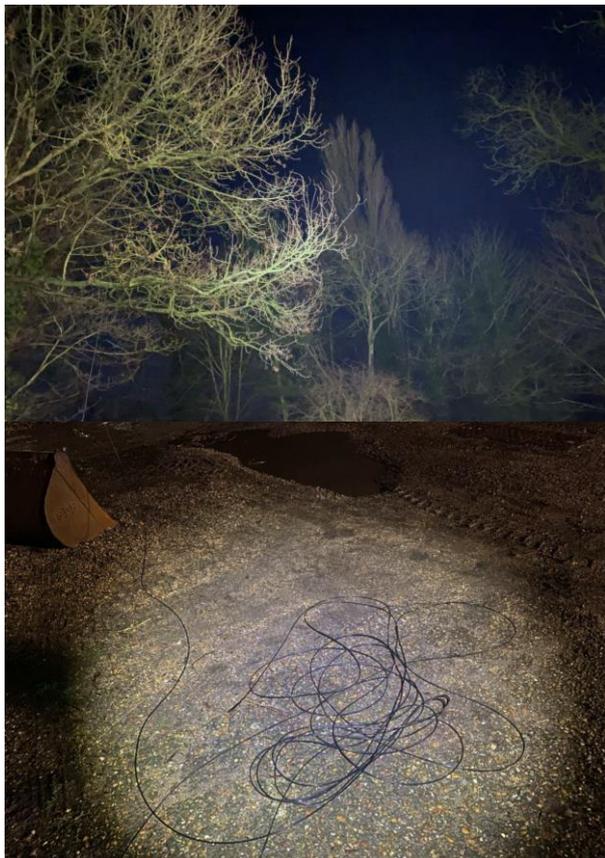
- While offloading attachments from a wagon at Offord level crossing
- RRV arm caught an overhead telecoms cable.
- There was very low visibility of the cable, and the cable was in the trees.

- Low visibility

- reported to on call.
- Statements taken.
- D&A post incident testing completed.

- Level 1 Investigation to be complete.
- Delivery & Collection plans to be reviewed
- Contact service provider to plan repair.

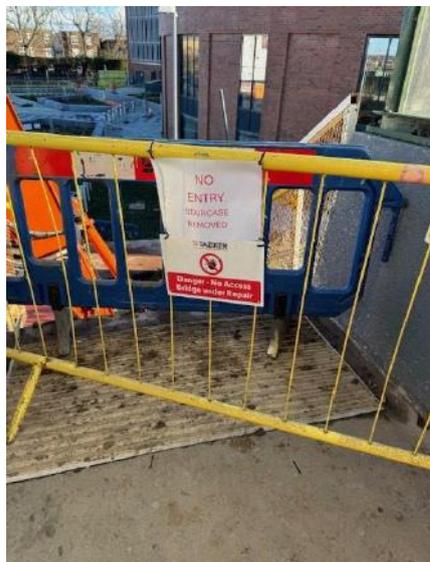
Before

The two operatives had been instructed by Taziker management to retain the existing safety barrier in place and fit the end section of the Kee-Klump to the footbridge to create a work area free from leading edges. However, during the measuring phase of work, one operative briefly removed the Chapter 8 barrier separating them from the leading edge to take measurements up for the Kee-Klump stop-end.

- Temporary Chapter 8 barrier was removed, exposing an open leading edge.
- Operatives accessed the area without using available fall protection.
- The safe system of work did not reflect the changed site conditions following staircase removal.

- Work was stopped and the temporary barrier reinstated.
- Task re-planned to include fall restraint and the team re-briefed.

- Any change to site conditions must trigger a review of the safe system of work.
- Temporary controls must not be removed without suitable alternatives in place.
- Stop work if controls are missing or conditions differ from what was briefed

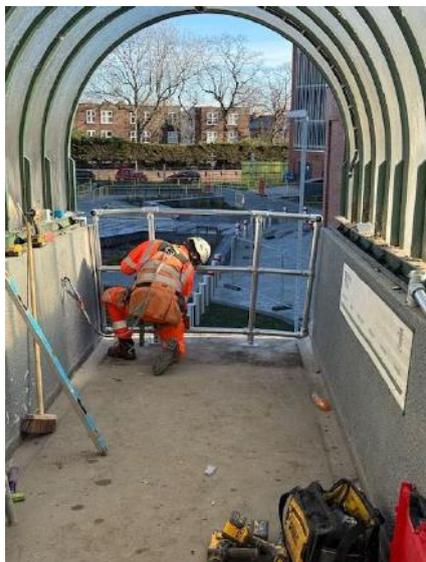
After realising their error, the two operatives replaced the temporary barrier, and returned to the site compound for their break. Here, they self-reported the Life Saving Rule breach to the Taziker site manager, who notified our Framework and Health & Safety Manager of the breach. To ensure the site was left in a safe condition, the Kee-Klump was fully installed using the correct fall restraint equipment.
