6 – 12 February 2026

This is a collation of some of the more noteworthy entries to find their way into Network Rail's Daily Incident Logs. The entries are not, therefore, the final versions of the cases in question, but the first.

Co-ordinated by Greg Morse, Operational Feedback Lead, RSSB

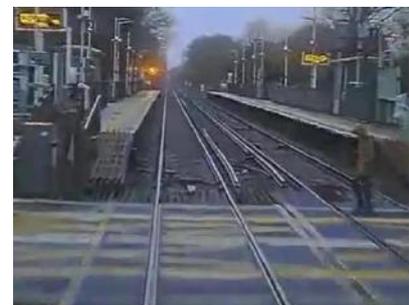
11 February: Near miss with child at Nutbourne AHB

At 07:47, the driver of a Brighton–Southampton Central service reported a near miss at Nutbourne AHB with a child. The child walked out in front of the train, causing the driver to sound the horn and apply the emergency brake. The driver was fit to continue after checking at the rear of the train that the child had not been struck.

Following trains were cautioned and no persons were seen at the crossing. The crossing equipment was confirmed as working correctly, so normal working resumed at 08:01. [Southern \(Sussex\)](#)

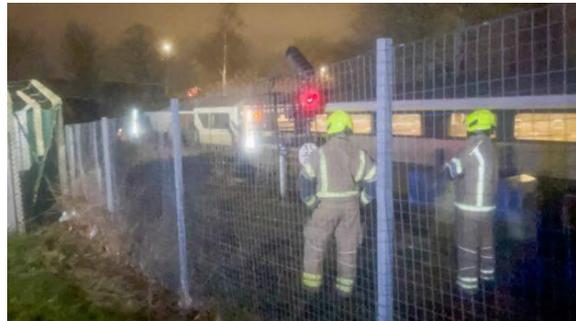
7 February: Electrical fire fells HST power car near Elgin, train evacuated, driver treated

At 14:29, the driver of a Dyce–Inverness HST service reported that smoke had entered the driver’s cab. At 15:18, the conductor on board initiated a Railway Emergency Call to report that the leading power car, 43168, was on fire, and that the train was on the Aberdeen side of Elgin station. BTP and the Fire Service were advised.

The driver reported that they had deployed the on-board fire extinguisher after seeing flashing and sparking, with fire emanating from the cab instrument unit and advised they had inhaled smoke. It was confirmed that no smoke entered the saloons. Police Scotland, Fire Service staff and Ambulance staff were on site by 15:45, and gave medical assistance to the driver. The Fire Service advised that the fire appeared to be electrical, adding that they were in the process of slowing the spread.

A controlled evacuation to ballast with egress from the railway via an access point was authorised at 16:22, with evacuation beginning at 16:31. RAIB were informed by telephone at 16:25. The driver was taken to hospital at 17:16 as a precaution. A fitter arrived at 17:32. A relief driver was dispatched to site. As there was no power in the power car, a second HST set was readied at Inverness and was on the move at 19:15. The assisting train was authorised to approach the failure at 20:14, and arrived on site at 20:20. Following coupling and checks the combined train was ready to depart when an issue with the brakes of the assisting set was discovered. This was overcome by the fitters and the combined set was on the move at 21:39 to Inverness at 20 mph. [Scotland’s Railway \(Scotland\)](#)

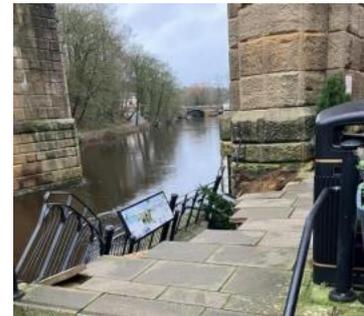
8 February: River embankment wall fails near Knaresborough Viaduct

At 16:06, a member of the public reported via the helpline a post on social media regarding a wall collapsing by the Knaresborough Viaduct and advised that the police were aware. BTP officers on site reported a 15-foot in length sink hole in the river wall, adjacent to the viaduct support. A suspension of services was initially imposed, and the MOM was sent to site.

Structures on call was advised and requested an immediate response. The line was blocked between Knaresborough and Harrogate. The MOM arrived at 17:25, with a structure examiner following at 18:33. The latter authorised the line to reopen in both directions at 19:10 with a 10-mph emergency speed restriction (ESR) in place. Normal working was resumed from 19:51. Eastern (North & East)

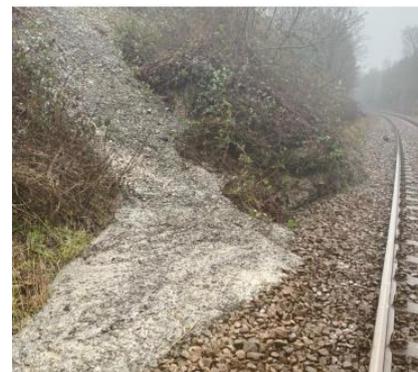
11 February: Landslip found on Sheffield side of Woolley Tunnel

At 08:15, the driver of a Leeds–Sheffield service reported a landslip and a tree slipping down on the Up Main, on the Sheffield side of Woolley Tunnel. The train had struck the tree, but was able to continue to destination. The line was blocked as a result with some services cancelled, or diverted via Wakefield Westgate and Moorthorpe where possible.

The MOM and Off Track staff were on site at 09:01 and 09:20 respectively. A Line Blockage of the Up Main was granted. The inspection confirmed that the landslip was approximately 18 inches from the cess rail and was still moving, with the risk of it encroaching onto the track remaining high. A Geo-Tech team was requested to attend, arriving on site at 11:04. Further assessments from a senior engineer confirmed that the line was required to remain blocked for the rest of the day due to the large amount of material that required moving, in addition to further movement occurring. A possession of both lines was granted at 23:11, and was planned to be handed back at 08:00 (Thu) with the Up Main available subject to a 20-mph ESR. Remedial work was ongoing at the close of the Log. [Eastern \(North & East\)](#)
