14 – 20 March 2025

This is a collation of some of the more noteworthy entries to find their way into Network Rail's Daily Incident Logs. The entries are not, therefore, the final versions of the cases in question, but the first.

Co-ordinated by Greg Morse, Operational Feedback Lead, RSSB

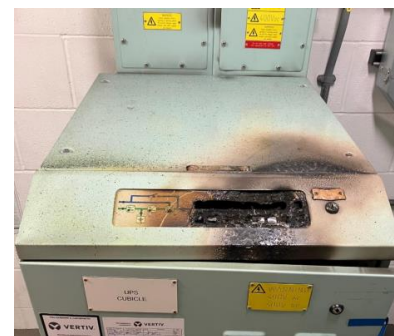
At 18:39, the MOM reported that there was a fire in the Uninterruptable Power Supply (UPS) room, an LUL asset at the rear of Platform 4 and LFB had requested a suspension on train running whilst they tackled it. LFB were delayed in tackling the fire due to batteries in the UPS room that required to be isolated. Train running remained suspended at the request of the LFB due to excessive smoke at Farringdon station.

At 19:26, the MOM advised that the batteries in the UPS room had been temperature tested by the LFB and train running on both lines could resume, albeit with trains not calling at Farringdon in the Northbound direction due to LFB equipment on platform 4. Trains were authorised to call at Platform 4 from 20:09, normal working resumed. Southern (Sussex)

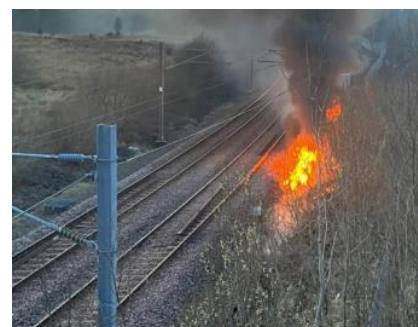
The driver of an Edinburgh Waverley–Milngavie confirmed at 16:51 that the fire was spreading and the fire service were called. The Edinburgh IECC Shift Signaller Manager advised at 17:21 that all signalling had been lost in the Caldercruix area and S&T staff were advised at 17:24. BTP and OLE staff were also advised.

A Line Blockage was imposed at 17:58 between Bathgate and Caldercruix and at 17:59 the fire service reported they had located a cable fire in the Caldercruix area. The MOM arrived on site with the police at 18:12. Replacement road services were implemented between Airdrie and Bathgate. An emergency isolation was implemented from 18:24 until 18:51 whilst the fire service extinguished the fire.

An Asset Recovery Manager (ARM) was appointed at 19:06. OLE staff completed a visual inspection at 20:12. The ARM confirmed at 20:35 that repairs would not be completed by close of service but should be able to resume tomorrow (Friday) morning. The police and fire service departed and the blockage was handed back. The ARM stated at 21:16 that a further Line Blockage was being taken in order for S&T and telecoms staff to assess the fire damage. Repairs were ongoing at the close of the Log. [Scotland's Railway \(Scotland\)](#)
