# PRB CONSULTING

## Rail Safety Bulletin

Issue 009 - October 2025

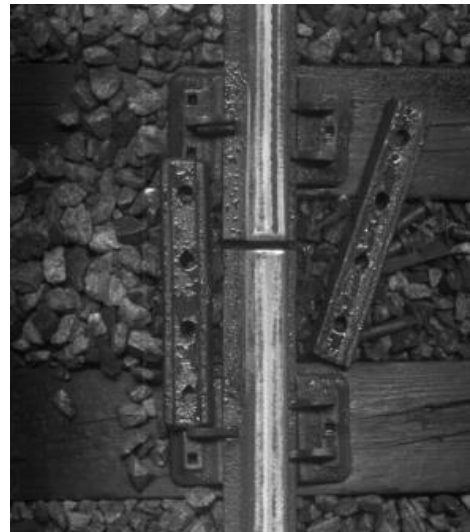
On Thursday 4 September a review of data gathered from an Ultrasonic Test Unit train identified a track joint with all bolts and fishplates detached from the rail at Park South on the Cumbrian Coastline.

A Basic Visual Inspection (BVI) of the track was completed at this location on 20th August in a routine midweek night line blockage. The BVI identified a cracked fishplate at a joint adjacent to this one.

Due to difficulties in installing the replacement fishplates, the fishplates on the adjacent joint were removed to allow some movement of the rail. For reasons not yet understood, these fishplates were not reinstalled before the line blockage was handed back.

Actions were taken immediately to protect the line until repairs were carried out.

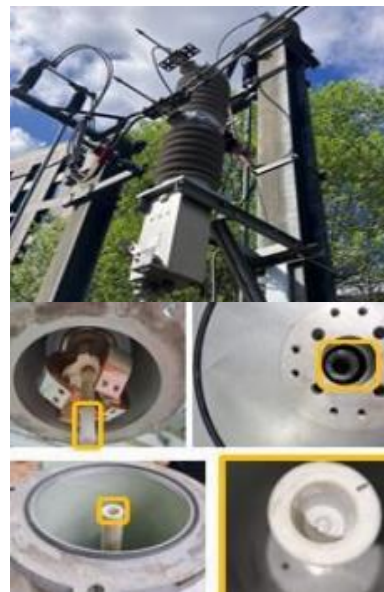
Subsequent investigations have found that a Circuit Breaker, which is an ABB supplied FSKII Circuit Breaker (top photo), had failed in the closed position.

| <ul style="list-style-type: none"><li>• <b>Failure Cause:</b> The operating rod became detached from its base within the high-voltage (HV) pole. This detachment disrupted the mechanical transmission chain between the actuator and the vacuum interrupter, preventing proper operation.</li></ul> | <ul style="list-style-type: none"><li>• <b>Site Testing &amp; Inspection:</b> Mechanical testing was conducted on the remaining FSKII units installed in Finnieston. Measurements of closing and opening time travel curves were compared against Factory Acceptance Test (FAT) certificates, confirming consistent alignment and positive results.</li></ul> |
| <ul style="list-style-type: none"><li>• <b>Vacuum Interrupter Condition:</b> The vacuum interrupter was inspected and found to be free of abnormalities. It remains fully functional.</li></ul> | <ul style="list-style-type: none"><li>• <b>Analysis of Similar Units:</b> A detailed examination of FSKII (FT/PR2), which had similar operational exposure to the original faulty FSKII (FT/PR1), was performed. Upon disassembly, the operating rod did not exhibit the same failure mode.</li></ul> |
| <ul style="list-style-type: none"><li>• <b>Supplier Investigation:</b> A detailed review of the operating rod's supplier did not reveal an underlying design flaw.</li></ul> | <b>Further Investigation:</b> A detailed analysis of an FSKII manufactured in the same batch as the faulty unit is planned to determine any potential batch related issues. |

Where an ABB FSKII Circuit Breaker is being used to affect an Emergency Switch-Off, a second open point shall be created in series with the FSKII breaker before confirming that the ESO has been taken.

Where available, the second open point should be a motorised air-break disconnecter (e.g. Busbar disconnecter) but otherwise may be the TNO/DNO Circuit Breaker, Feeder circuit breaker, bus coupler, set of track feed circuit breakers or overhead line switches and may be another FSKII circuit breaker.

Until testing is completed, the operational restriction indicated above may be lifted for all FSKII breakers installed in NR infrastructure, except those manufactured in 2018.

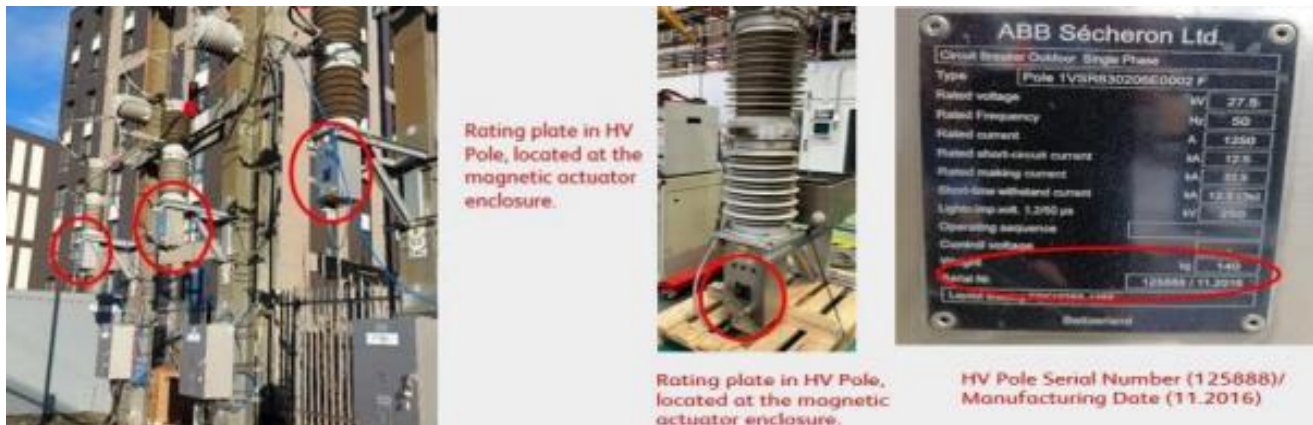
The manufacturing date can be found in the rating plate in the HV pole, refer to the following pictures:

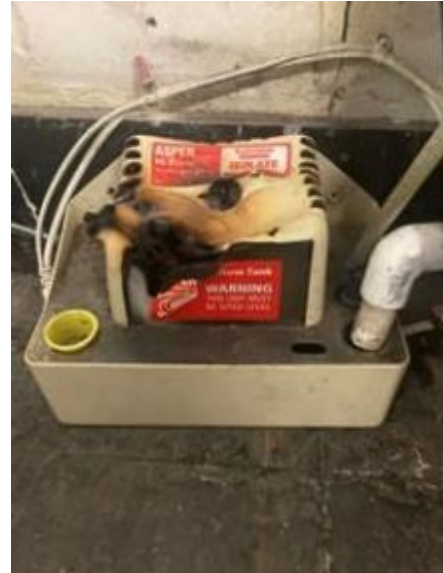
On Sunday, 14 September 2025 at 11:55, the Signaller at Warrington Power Signal Box (PSB) reported activation of the fire alarm within the Telecommunications Room. The Signalling Supervisor promptly obtained the key to access the room, whereupon they discovered the area was filled with smoke. The Fire and Rescue Service was immediately contacted.

The Fire Service arrived on site at 12:04 and determined that the source of the smoke had self-extinguished prior to their arrival. The origin of the incident was identified as the Aspen Hi-Flow Condensate Pump, as depicted in the attached photograph. No other equipment within the room sustained damage as a result of heat or smoke. Notably, no fire suppression systems or water-based extinguishing methods were required or deployed. As a precautionary measure, the Fire Service isolated the air conditioning unit and disconnected the pump from its power supply.

The precise cause of the pump failure remains under investigation. The unit has been inspected and returned to the manufacturer for detailed analysis. Further updates will be provided as additional information becomes available.

North-West route have reviewed their signal boxes and currently have this model of pump deployed at over 30 locations. These pumps are widely used across the country by all regions, so all areas should review their asset information.
