December 2022

Rail Safety Bulletin

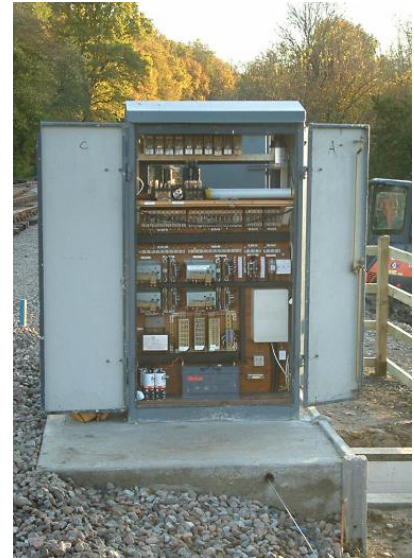
Figure 1 stock image

Ballast cleaning works undertaken in the area required disconnection at DY586 signal and associated equipment. When the signalling system was reinstated following completion of the track works, the yellow and red aspects on DY586 signal were transposed.

The incorrect aspect sequence resulted in the first train passing the signal at red when it should have been yellow, and a yellow aspect shown to the following train when there was a train in the forward section.

Testing to reinstate the signal after the works, was not carried out in accordance with the Signal Maintenance Testing Handbook (SMTH). Testing steps in the SMTH would have identified the transposition of the aspects had they been followed. The error was not self-revealing.

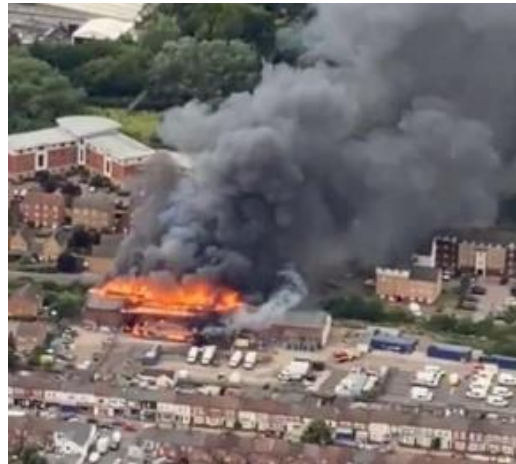
It was initially reported that the cause of the fire was from the charging of Lithium Ion Batteries (LIBs) on unsuitable shelves. Following initial evidence gathered by the investigation team, the Ledlenser iFR8 lamp was temporarily quarantined.

During the investigation the exact source of the fire could not be identified with certainty. However, it was likely that the cause was from either the charging station sockets, the building wiring or the charging cable.

The building maintenance Electrical instal condition report (EICR) could not be found and testing had not been completed for a number of years prior to the fire occurring.

The investigation found numerous gaps in statutory testing, not isolated to Northampton Depot. This could not be ruled out as a contributory factor to the fire starting.

Following the conclusions drawn from the investigation, the temporary restriction of the iFR8 lamp should be lifted with a cautionary note that all plug and play devices should only be used, stored and charged in accordance with the manufacturer's instructions. That charging facilities are fit for purpose. And that fire risk assessments are suitable and sufficient and the finding of which acted upon.
