December 2021

## Rail Safety Bulletin

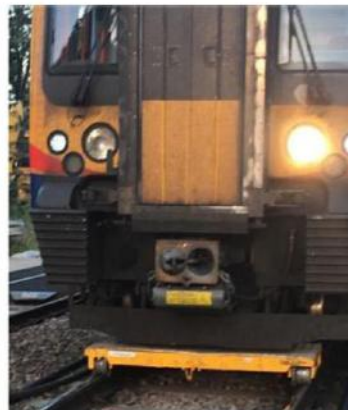
Ref: NRA21-14

On Wednesday 8 September 2021, after a possession had been given up, a passenger train struck a hand trolley that had been left on the Up Main line near Twickenham Station.

On collision, the trolley became wedged under the front carriage of the train.

The line through Twickenham is an axle counter area and subject to the requirements of Network Rail Work Instruction NR/L3/OPS/084 'Line Clear Arrangements following Engineering Works in Axle Counter Area – Line Clear Verification process'.

- All COSSs, Safe Work Leaders (SWL) and Engineering Supervisors (ES) must comply with their duties relating to line clear verification (LCV), including complete worksite sweeps, to make sure the line is safe for the passage of trains before handing their worksite back.
- All vehicles, including hand trolleys, placed on the line must be recorded (by the Machine Controller / COSS / SWL / ES / PICOP) on the appropriate LCV forms and cross referenced when each vehicle is removed from the line.

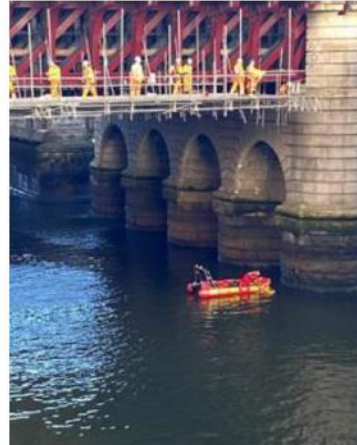
Ref: NRA21-15

On Friday 24th September, a scaffolding contractor was tasked with dismantling the tube and fitting scaffold between the south pier and the riverbank on a structure over water in Glasgow.

At approximately 09:15 one of the scaffolders was standing on a dropper tube when it slipped loose from its couplers, causing him to fall from the scaffold into the river along with the tube. His harness and lanyard were clipped on the same dropper tube.

- Always wear a harness when working at height, and know where your suitable anchor points are, unless other protection is in place.
- Ensure documented erection and dismantling procedures are in place and communicated.
- Ensure the control measures are being implemented and followed.
- Ensure life jackets are worn during all scaffold erection, dismantle and alteration works above watercourses.
- Ensure personal fall protection equipment (e.g. harness, lanyard, inertia reel, etc.) is relevant to the task, frequently inspected and maintained, and suitable anchorage points are utilised.

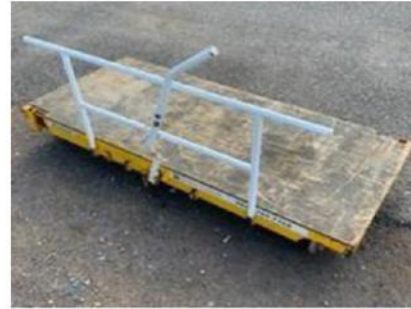
Ref: NRA21-16

At 06:10 on 21st October, a GWR Intercity Express train service struck a half link trolley on the Down Main at Challow (83m MLN) between Didcot and Swindon at around 100mph. No injuries were reported.

The train was damaged with the trolley wedged underneath, stranding 135 passengers. It could have been derailed. The Down Main only re-opened at line speed 3.5 hours after the incident causing significant delays and disruption to our passengers.

The trolley had been left on the access point following rail defect weld repairs, and was the only one in use by the team that night.

- The COSS must request permission to place trolleys on the line from the ES and advise when they are removed.
- The PIC/COSS must tell the ES when their site of work is complete and safe for the passage of trains.
- The ES must check and confirm to the Person in Charge of the Possession (PICOP) that all of their worksite is safe for the passage of trains.

- Process NR/L3/OPS/084 'Line Clear Arrangements following Engineering Works in Axle Counter Area - Line Clear Verification Process' must be followed.
- The ES and COSS must independently record when anything with two or more wheels (such as On Track Plant, trolleys or skates) is put on the line and when it is removed, and confirm this as part of handback.
- The relevant forms must be cross referenced when signing out from the worksite.
- The PICOP must verify with the ES that the relevant forms have been completed and the line is clear.

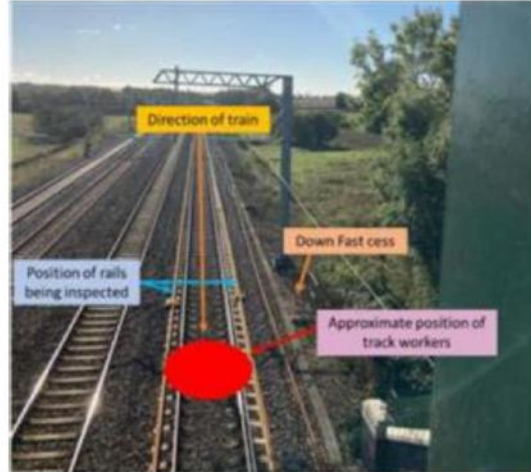
Picture: Location of near miss.

At 09:58 on 6th October 2021 the driver of a passenger train saw two track workers in the four-foot ahead of their train. The driver sounded the train horn, applied the emergency brake and reported the near miss. He had to be relieved from driving at Kettering station. A Mobile Operations Manager (MOM) attended the site and arranged drugs and alcohol testing.

The track workers had been checking lengths of rail that had been dropped in the location ahead of renewal works, remained in a safe position not affecting running rails. Their safe system of work was 'separated by distance', allowing them to visually check rails from the Down cess. However, overhead line stanchions and an overbridge affected being able to stay the required distance from running lines.

Front facing train video footage indicates that the two track workers had been in the four-foot and reached a position of safety barely five seconds before the train passed. To exit the railway, the two workers crossed four open lines.

- Review all SWPs for forthcoming works where the safe system of work is separation.
- Verify that the planned activities can be safely performed this way at each specific location.
- Identify whether there are safer alternative means of performing tasks, i.e. removing the need for people to go on track.

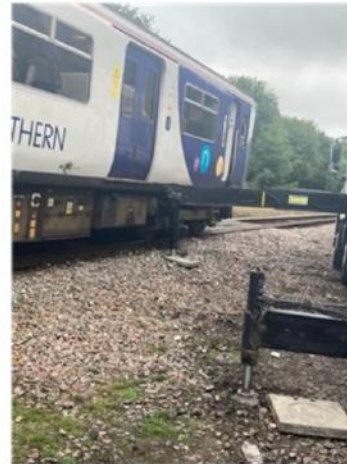
Ref: NRX21-10

On the 27th August 2021, a portable toilet unit was being collected by a HIAB lorry mounted crane from Oxspring renewal site between Penistone Station and Oxspring Viaduct.

As part of the activity, the HIAB driver deployed the outriggers in order to lift the toilet unit. At approximately 08:45hrs a passenger train came into contact with the front left outrigger causing superficial damage to the train.

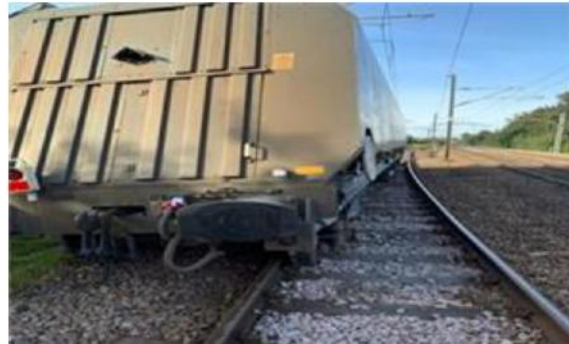
Ref: NRB21-09

At 14.22hrs on the 10 October 2021 an empty stone wagon ran away and derailed on a set of trap points at Wrenthorpe Sidings, Wakefield Westgate on Network Rail infrastructure.

This incident is currently under investigation by the British Transport Police (BTP) as a malicious act by juveniles who intentionally released handbrakes on a number of wagons, before detaching the wagon which ran away.

Action was immediately taken to review site security arrangements, additional BTP officers were deployed; and a review was undertaken to look at the possibility of permanently isolating the Overhead Line Equipment (OLE) at this location.

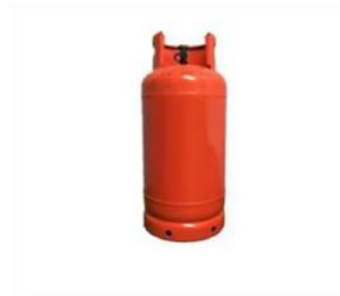
Ref: NRB21-10

A team of contractors working for Capital Delivery went into Sevenoaks tunnel intending to use oxy-propane cutting equipment to cut some metal work out of one of the ventilation shafts. A welding team from maintenance told the contractor team they could not use propane in the tunnel. The oxy-propane equipment was removed.

The contractors were cutting at a high level in and around the ventilation shaft in the tunnel. The contractor had assessed the risks and identified that a leak or release of acetylene, an alternative fuel gas that is lighter than air, may collect in the vicinity. Application of a flame may then ignite it.

For that reason, the work planning had rejected the use of acetylene and chose propane as a safer alternative for this specific task. Network Rail's company standard for welding the track (i.e. at ground level) only recognises use of acetylene because propane could gather at a low level creating a fire or explosion risk.

- Using any flammable gases in tunnels or ventilation shafts involves increased risk and alternative methods should always be considered.
- All confined space welding or cutting tasks that plan to involve either propane or acetylene must be thoroughly risk assessed in advance.
