June 2023

Rail Safety Bulletin

Contents

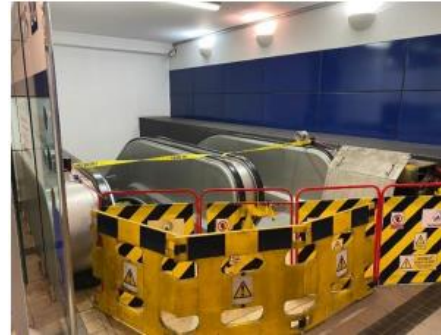
On the 17th of May, a KONE escalator model E3X malfunctioned at Argyle Street Station in Glasgow.

The escalator failed unexpectedly, causing an uncontrolled reversal of direction.

Twelve people were on the escalator at the time and several of them suffered minor injuries.

Immediately following the incident and trying to help, a member of station staff boarded the escalator to aid passengers, however, this caused the escalator to start moving uncontrollably again.

This incident is now under investigation. While the investigation is underway Network Rail Route Services are conducting additional testing of all E3X machines over the next 4 weeks.

- How do you ensure your own safety when responding to accidents and incidents?
- Don't rush onto a failed escalator. Think about why you need to go on it. Think about how you can help get people to safety.
- Do you and your team have a plan for emergency events?
- What extra information might you need to help manage such incidents appropriately?

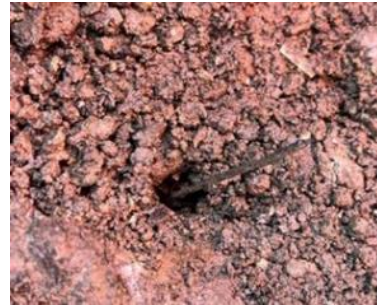
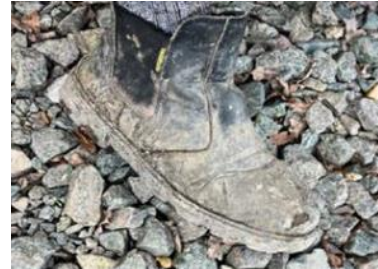
Whilst hand digging a trial hole, an operative came into contact with a buried sharp steel spike which penetrated the non-reinforced sole of their boot, causing a minor puncture wound to their right foot.

Had they been wearing the correct boots with midsole protection, this would most likely not have resulted in an injury.

The sponsor had allowed the operative to purchase their own PPE with insufficient guidance and did not carry out adequate PPE checks / assurance prior to them starting on site.

The poor protection offered by unsuitable boots was discussed with the individual and they were made aware of the importance and need for high standard, compliant footwear for the construction work they were undertaking.

PPE checks were immediately undertaken across all sites to ensure compliance with Network Rail's Standard and the content of future sub-contract orders is to be reviewed to include full PPE specification requirements.

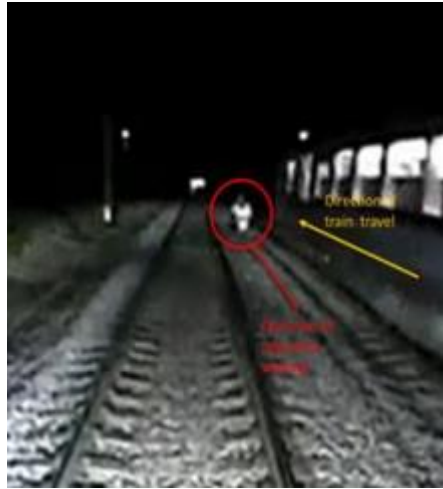
At 01:50 on 13th May 2022, a tamper operative arrived at a site access point. After being briefed and signing in with their COSS, the operative walked un-accompanied in the 4-foot of the line under possession towards the tamper that had already started work.

CCTV footage shows that as the operative neared the tamper, they stepped into the 6 foot and then moved as if to step into the 4 foot of the adjacent line.

The adjacent line was open to traffic at line speed and at that moment, a train passed the operative, causing them to step back.

The incident was not reported in real time by any of the staff nearby nor the train driver, yet the event was clearly very close to being a fatality. The event was reported as a close call at the end of the shift.

- The COSS became distracted and did not accompany the operative to the worksite.
- The operative was a late substitute to make up a 3-person crew as contracted. However, this newer tamper could be, and was being operated safely with only 2 people.
- The operative was fatigued after being woken by their employer’s on-call, driving from Kent to North Essex.
- The employer’s on-call arrangement didn’t test whether the operative was fit to work.
- Although the operative was briefed at the access point, they were unfamiliar with the location.

- The COSS / person in charge makes sure any new person joining a group fully understands the limits of SSOW that will be in place, the operational site and task risks. If there is a distraction ‘Take 5’.
- Staff on-call to carry out a ‘dynamic’ Fatigue Assessment when called out to site. A Fatigue Management Plan should be in place for anyone on-call (Ref NR/L2/OHS/003 mod 5).
- When change occurs, like new equipment, review your risk assessments to check if you still need the same resources. In this case there was an opportunity to de-risk the activity by having fewer people on track.
- The COSS / person in charge can only supervise the safety of their work group if they are present. If a COSS / PIC moves away, the work group needs to be stood down to a position of safety until they return.

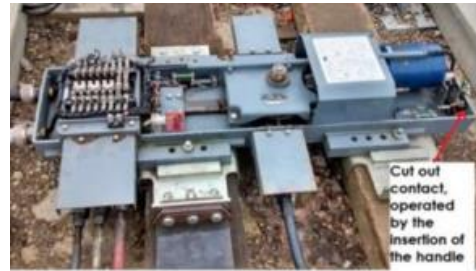
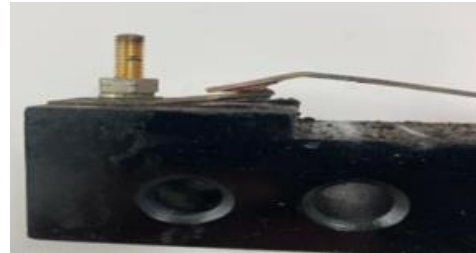
An S&T team were undertaking a full annual service to 2501B HW points at Ridham. The point winding handle was installed for manual operation and the technician began winding the points.

Once detection was lost the point machine motor then tried to drive back to normal. This spun the handle around at high speed with the technician's hand holding the handle.

Later that evening the IP felt some pain when they got home and went to hospital where they had an X-ray, which confirmed a small strain/hairline fracture to their metacarpal.

This is an extremely rare failure mode, however, until it is fully understood, the following discussion points are recommended:

- S&T Discipline - Are you and your team clear on:
 - SMS/PartC/PC05 3.1 Examine the crank handle cut out contact. Check that when the crank handle is inserted the contact breaks
 - SMS/PartC/PC05 6.1 Isolate the machine by inserting the crank handle and confirming the crank handle contact breaks
- When undertaking maintenance remain vigilant and report any defects to your line manager.

Until further notice it is recommended that once a point machine is believed to be isolated (crank handle inserted), stand well clear and request the signaller to swing the points. The points should not move. If they do, or any doubt please contact your local S&T section for advice.

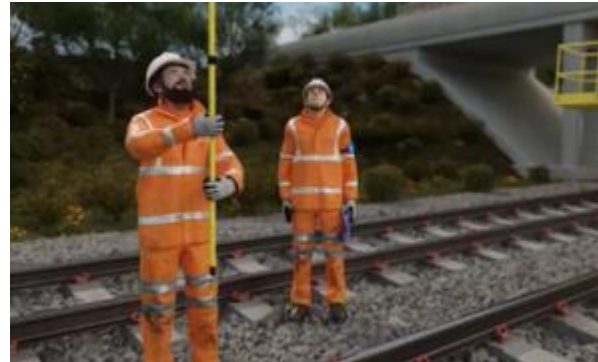
We have received reports which highlight that Live Line Indicators aren’t being tested and calibrated in accordance with the overhead line work instructions (NR/L3/ELP/27237).

If you come across a Live Line Indicator that is outside of it's calibration date, place the item in quarantine, mark it ‘Not for Use’, and raise a close call.

- All Live Line Indicators must be calibrated and tested in accordance with the overhead line work instructions standard (NR/L3/ELP/27237).
- Only Live Line Indicators with a valid calibration certificate must be available for use.
- When selecting the Live Line Indicator, you must check a successful weekly test has been completed or complete a test on a known live 25 kV conductor prior to use.

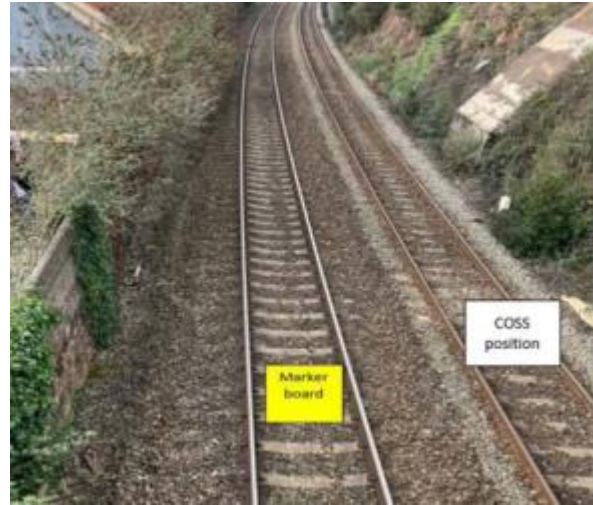
On the 14 February 2023 at Teignmouth Boat Yard, near Dawlish, at approximately 01.18am a Controller of Site Safety (COSS) went to place worksite marker boards after being asked to assist the Engineering Supervisor (ES) in taking a worksite.

Believing they had been told to place the marker boards, the COSS accessed the track and walked to the required position and placed the marker board on the Down line, whilst placing the marker board they heard a train coming and moved quickly onto the open Up line as the train hit the marker board.

Permission to place the marker boards had not been given by the ES and both lines were still open to traffic. The forward-facing CCTV footage from the train shows the COSS moving clear from the down line 4 foot into the open Up line with less than 3 seconds to spare before the train hit the markerboard.

- How you make sure plans and resources are adequate to undertake the task?
- How do you assess the impact of changes to the possession / worksite plan and availability of resources, and you assure yourself those changes are correctly communicated and understood?
- What can you do to make others feel able to challenge any communication if something is not clear or accurate and how do you make sure people clearly understand the actions you want them to take?
- Are you using communication protocols such as, repeating back critical information, using the phonetic alphabet, confirming next actions, locations, lines, mileages and times?
- What can you do to make others feel able to challenge any communication if something is not clear or accurate? How do you make sure people clearly understand the actions you want them to take?
