October 2023

Rail Safety Bulletin

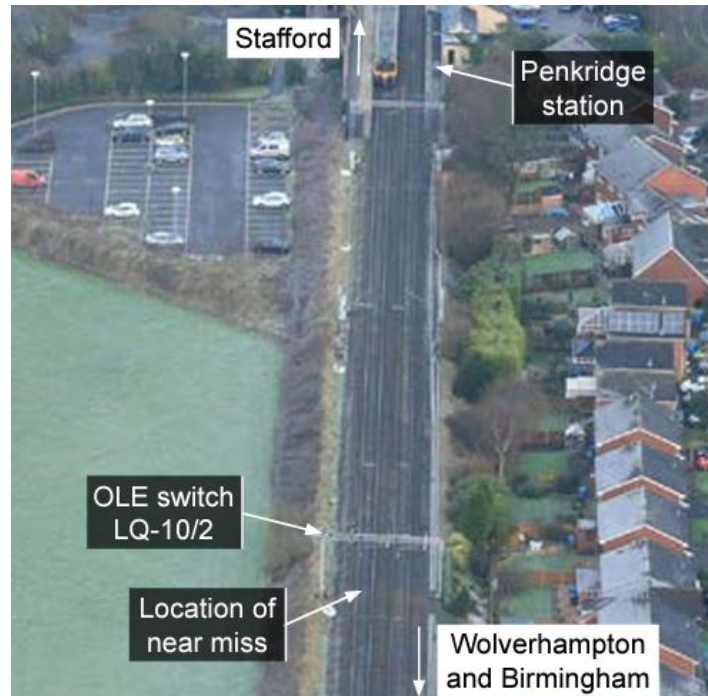
At 23:58, the train driver saw two track workers on the line they were travelling on and sounded the warning horn without having time to apply the emergency brake.

Initially it was reported back by the OLE team the technicians were positioned in the cess, however later onboard footage confirmed they jumped clear of the trains path at the last moment.

The two OLE technicians did not have a Safe System of Work (SSoW) when they left the work group to operate the switch.

Front-line Staff: Life Saving Rules save lives – A valid, implemented safe system of work would have avoided the risk of a fatality in this instance. The person in charge shall not allow the implemented SSoW to be comprised for any reason. Where there are changes in circumstances that affect the SSoW, the person in charge shall make sure everyone in their workgroup moves to a position of safety, and only then shall they reassess and implement appropriate changes in line with the requirements of 019 and the rulebook.

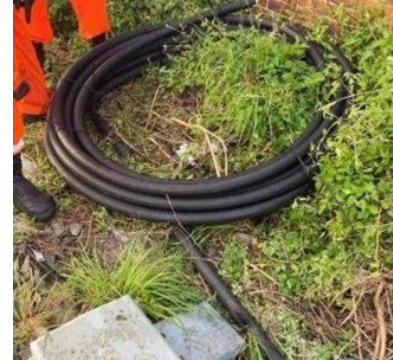
On 4th May 2023, EK2033B points at Gillingham pierced a live traction cable that had become caught in the point machine. The incident punctured the insulation of the cable causing a short circuit and damage to the point machine. The short circuit meant that the lock/detection blades became live and could have caused injury to any operator using the manual winding mechanism.

The section of cable which was pierced was due to be replaced as part of planned project work that night. The coiled-up section had been delivered to site for this replacement work. This cable was propped up against the wall and subsequently slipped down, pushing the live cable section towards the point machine. Subsequent operations of the points led to the machine blade ends coming into contact with the cable and ultimately pierce / puncture its insulation layers, exposing the live conductor cable. Following a point movement, the lock / detection blades came into contact with the live conductor causing a short circuit.

- Are you and your team fully checking for the proximity of traction cables during points maintenance?
- Are you and your team storing and securing materials in a safe way, thinking about how it might move and what might happen if it did?
- Are you compliant to the cable separation standard (NR/L3/ELP/27250/CRE805)? Remember, no traction cable should be within 500mm of a point machine.

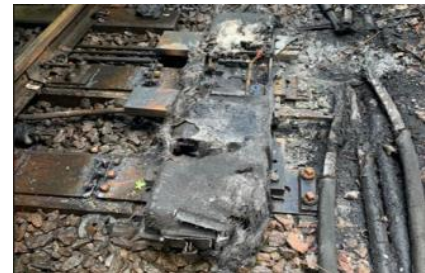
On 19th June 2023, NK2251B points at Gravesend pierced a live traction cable that was near the machine.

During operation of the points, the movement of the lock and detection blades (with threaded ends) punctured the insulation of the cable. 2L31 then passed over the points and this additional pressure created a catastrophic short circuit that destroying the point machine, 4 traction cables, sole plate & stretcher bar insulations as well as track circuit equipment.

It also damaged a train that was stopped over the crossing.

The Route has commenced a specific check on all point machines on the area and already identified two further point ends where action is required to remove the risk.

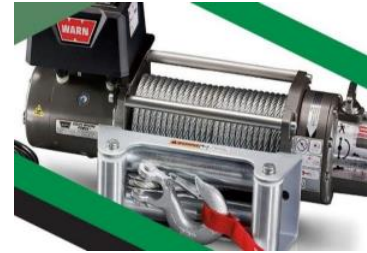
Warn Industries advise that a defect exists in the handheld remote control device that was sold with WARN VR EVO winches. A small number of remotes which have been exposed to, or submerged in water have exhibited failures that can result in unintended winch operation, which may increase the risk of injury.

Note, only the remote is subject to this recall notice, the winch is not affected.

1. Inspect the remote for any internal corrosion or signs of water ingress.
2. Open the remote by removing the 3 screws and remove the batteries (1 x Li-ion or 3 x AAA depending on manufacturing date). Removing these batteries disables the wireless function of the remote.

3. If no corrosion is found, the remote can still be used to control the winch but only when physically plugged into the winch control pack.
4. Discard the batteries, you will not reinsert them back into the remote during reassembly.

5. If corrosion is found, the remote can no longer be used and must be replaced.
6. Reassemble the remote using the 3 screws without the batteries.
7. Contact your local WARN Distributor to obtain a refurbished or replacement remote. This may be a wired only remote as an interim solution while you wait to receive a refurbished or replacement wired/wireless remote when available.

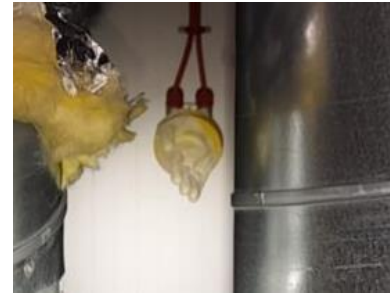
The fire detector was located in the ceiling space of the male toilets between two sets of ducting.

A rubber glove was placed over the smoke detector, preventing potential smoke in the event of a fire from activating the audible fire alarm. The incident was reported to senior management with a Close Call being raised. The glove was then removed, when safe to do so, to retain the full working order of the fire system and safety of the occupants.

- Any works completed which could affect an automatic fire detection system should have an approved method statement in agreement with the appropriate asset engineer. On completion of works, all contractors must verify and assure all systems are restored to their original status.
- Ensure all automatic fire detectors are checked and inspected on a six-monthly basis by the PRFS and record findings in the Fire Safety Log Book - NR/L3/FIR/109/F008

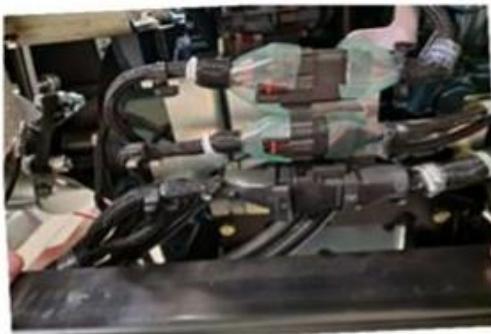
A number of GreenMech Woodchippers, EVO 205D SAFE and SURE-Trak models have left the factory without the Engine Harness Support Bracket being fitted.

1. Inspect EVO 205D SAFE and SURE-Trak models and confirm if retrofit work needs to be undertaken.
2. If work needs to be undertaken, parts should be ordered under:
 - ▶ Engine Harness Support Bracket – 4038913
 - ▶ Track Leg, Over Centre Valve Mount - 4038922
3. Any issues or questions should be directed to Service Department support@greenmech.co.uk or 01789 400044 Option 2

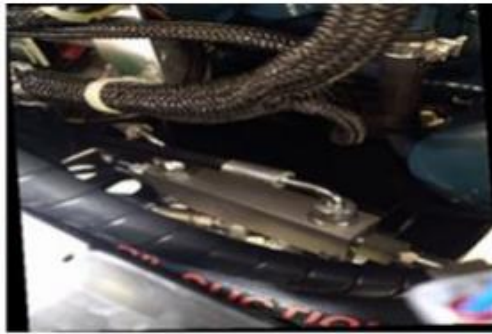
New position of over centre valve

GreenMech have now created a new bracket for retrofit, along with a new Over Centre Valve Mount which needs to be fitted in order to accommodate the new bracket and revised wiring loom position.

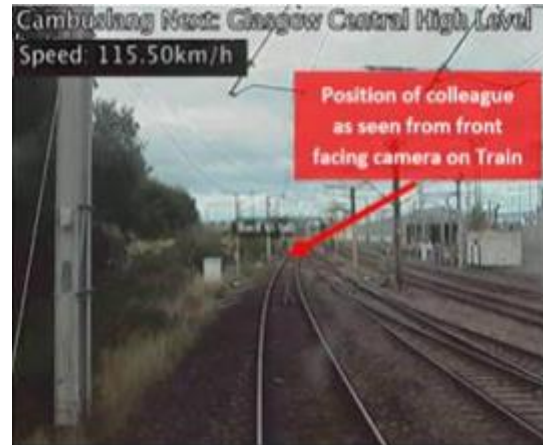
The train was travelling around a curve at approximately 75mph when the driver saw a trackworker in the 4ft and applied the emergency brake.

After completing their inspections, they stepped out of the agreed line blockage limits and onto the West Coast Main Line, which was open to train movements, and into the path of an oncoming train.

The trackworker managed to step back into a Position of Safety less than 5 seconds prior to the passage of the train on the West Coast Mainline, acknowledging the train warning by raising their arms.

Always stay within your protection limits.

Never work on an open line.

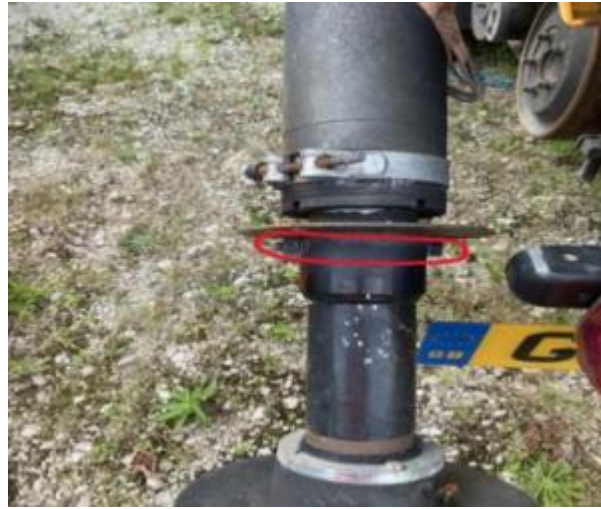
In North West and Central, a Geismar 18T MEWP was found to have a stabiliser foot assembly that had become completely detached from the stabiliser leg. The stabiliser legs are used in conjunction with the crane and can also be used to increase the reach of the basket.

Investigations are ongoing, but initial inspections have indicated that a combination of wear and corrosion have led to the single bolt connecting the foot assembly to the stabiliser leg failing.

- All stabiliser legs and feet assemblies to be thoroughly inspected by a competent person.
- Do not use the stabiliser legs on the Geismar 18T MEWPs until the inspection has been completed and any required remedial work has been carried out.
