# Shared Learning

## OLE Head Span Cable Strike

Ref: NRL24-07

Location: Darlington Station, Eastern region

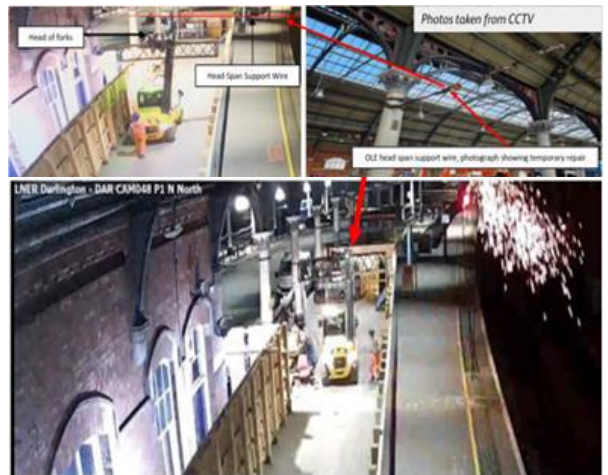
Whilst travelling within the hoarding, the load (3m length of steel) was lifted (boomed) over the hoarding using the telehandler (see photos). The Telehandler's head of the forks contacted the OLE head span support wire and brought the vehicle to a stop. The Plant Marshall checked the tires and then informed the operator that the tires are inflated and therefore couldn't identify any problem. The telehandler driver then continued forward pushing against the OLE head span support wire (see photo) which caused it to snap under the tension and likely came into contact with the live contact wire.

The event caused the adjacent circuit breakers to trip and resulted in 570 delay minutes whilst a temporary repair of the OLE head span was undertaken.

- Steel arisings were not planned to be raised above the hoarding.
- Steel arising were not cut into manageable sections to remain within the hoarding when transported.
- Change in methodology to transport materials was not risk assessed in accordance with [NR/L3/ELP/29987](#) module 2.
- Site Supervision never corrected or ensured that zoning arrangements and safe working practices were being adhered to throughout the shift.

- When working in proximity of NR OLE infrastructure (whether deemed live or not), a risk assessment is required to be in place in accordance with [NR/L3/ELP/29987](#) module 2.
- Site walk through with the designers, contractor and site staff must be carried out.
- When changes arise during planned activities, the collaborative consultation process must be revisited to re-view risks and control measures.
- Supervisors and operatives must check and challenge permits that are ambiguous without any control measures being identified or implemented.
- When putting people to work, briefings must be clear and concise with confirmation of understanding asked.
- Capability assessments to be carried out on all operations and personnel involved prior to commencing the task.
- Plant Marshall required to be in a position of safety out 3 meters away from moving plant(s).
