CLIC

Liverpool Street Station Roof Project, Renewals & Minor Enhancements

Issue 105
25th September 2024

Continuous Learning & Improvement Cascade
Eastern Routes Capital Programmes

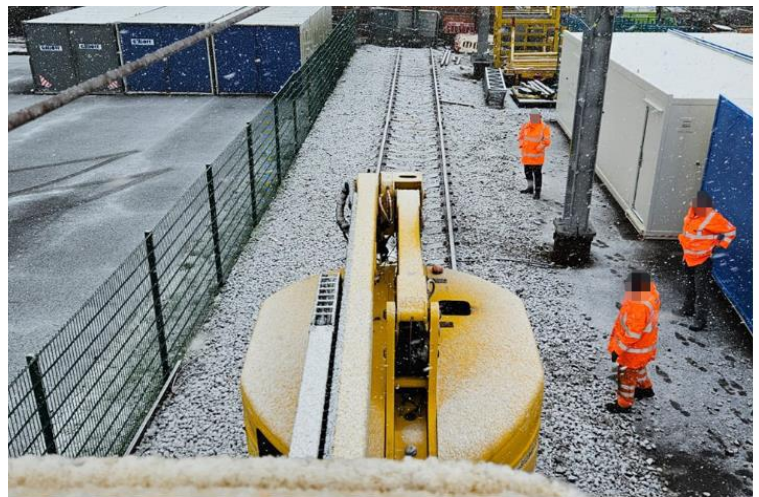
View from the raised operator's basket showing the restricted view of the track immediately ahead of the machine. (Courtesy of SPL Powerlines UK Ltd.)

The team were stationary for 25-30 minutes during which the Supervisor re-organised the team to enable higher productivity. During that time one of the Machine Controllers moved away from his allocated MEWP and was witnessed in a nearby safety refuge on the Down Main Line. After a visual check to ensure exclusion zones were clear the MEWP's proceeded their movements. It was at this point the Injured Person (IP) was identified in the four-foot. With all plant movements suspended, the IP was given first aid and then taken to hospital for a follow up assessment. The IP was uncooperative during the investigation and without witness or CCTV, it was not possible to confirm exactly what happened to the individual.

- Staff under investigation received well-being support
- 360-degree camera installation and front and rear cameras on plant
- Review and enhanced monitoring of behaviors and attitudes of safety critical staff

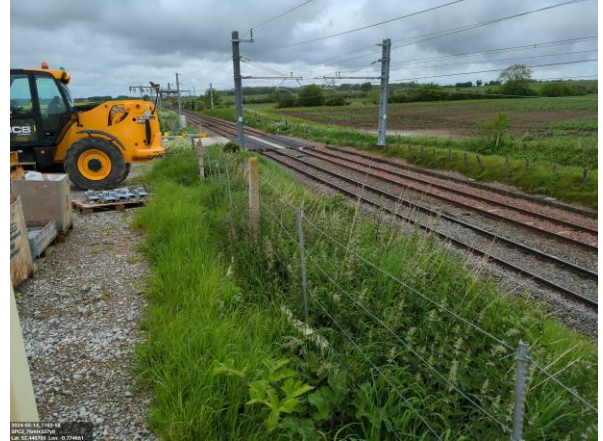
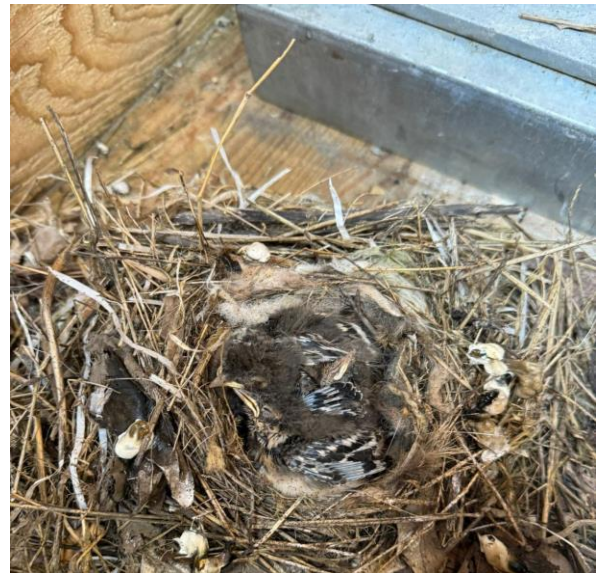
The following morning, while personnel were unloading the boxes, a nest containing 4 sparrow chicks was discovered at the very bottom of the box, previously hidden by materials. The discovery was promptly documented and reported to the SPL environmental team and ecologist. The ecologist advised to return the box and chicks to the compound as soon as possible. Despite the swift action of all of those involved, the chicks sadly perished.

Pictures of the compound location and the nest after it was discovered

- **Inadequate Inspection:** The box was not thoroughly inspected for nests before being moved. The standard visual inspections did not account for potential wildlife nesting in concealed areas.
- **Environmental Conditions:** The absence of lids on the boxes allowed birds to access and nest inside the boxes, leading to this incident.
