April 2022

Rail Safety Bulletin

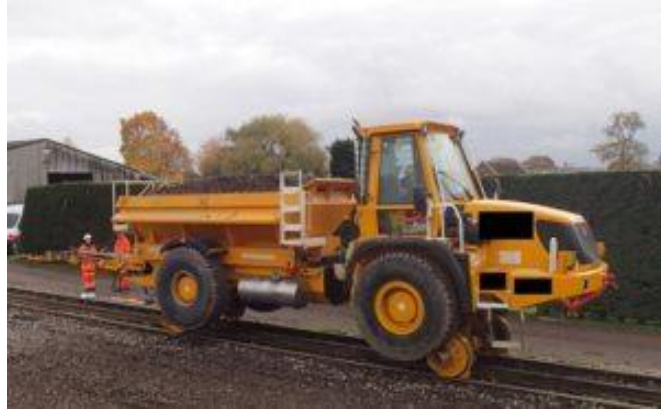
ORR found failings that led to a worker being crushed between the conveyor of a 25 tonne 'Superboss' ballast distributor (see image) and Kubota people carrier.

The worker suffered catastrophic and life-changing injuries to his legs and spine. He lost 12cm of bone to his left leg and 4cm to his right leg. The tendons and nerves of his right leg were also irreparably damaged, causing permanent disability.

ORR found failings in Network Rail's management of the worksite, including poor planning, failure to provide adequate supervision of the works, poor communication at all levels and failure to provide adequate information, instructions and training to safety critical staff.

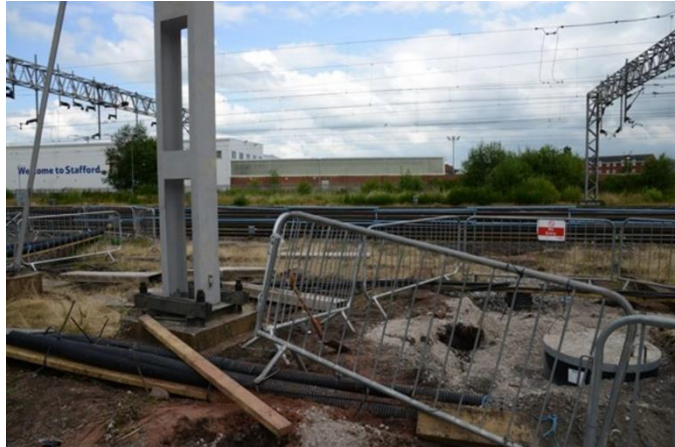
The incident happened on 6 July 2014, when an employee was working in a trench as part of a project carrying out excavation work outside Stafford railway station. The wall of the trench collapsed, burying the worker.

At the time of the collapse the excavation was approximately two metres deep and had been constructed without any support to the sides.

In its investigation, ORR found the company did not use temporary works (such as trench supports) to shore up the excavation despite evidence of unstable ground conditions, and expert evidence shows that had they done so the collapse would not have occurred.
